CRREL Report 82-1

The Alaska Good Friday Earthquake of 1964

George K. Swinzow

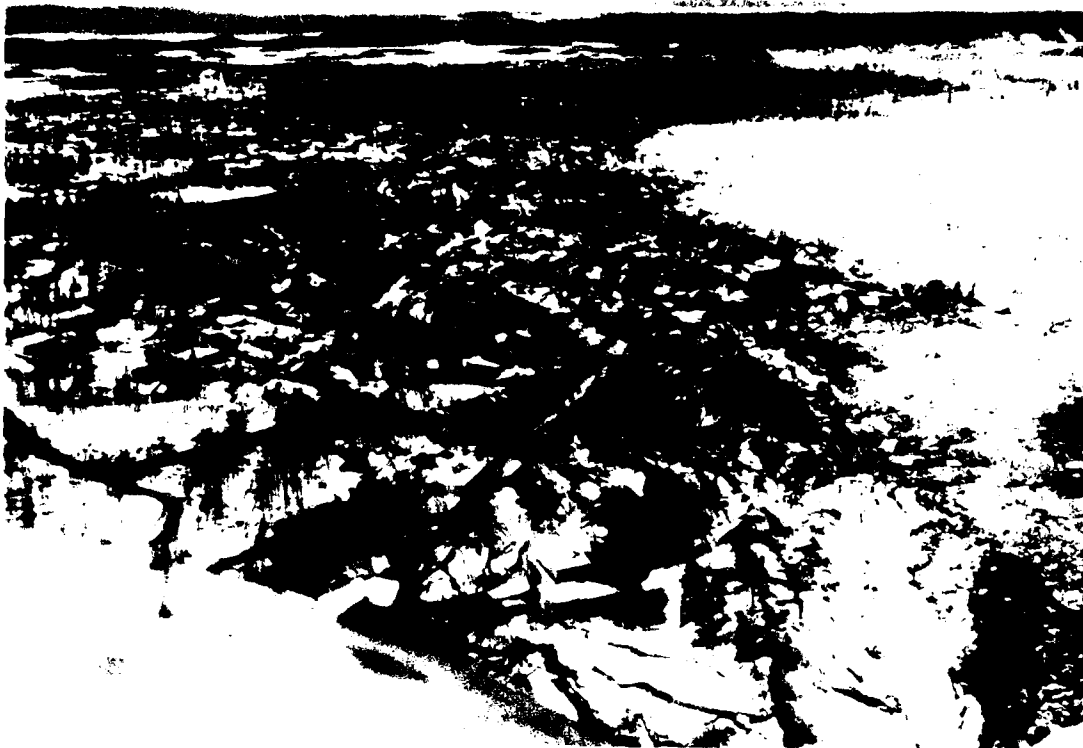
a. An aerial photograph taken from an altitude of about 500 feet, a mile from the center of the slide

b. A cross sectional interpretation along a line through the center of Figure 2a

Figure 2 The Turnagain Heights slide was a large, essentially horizontal slide. Turnagain, a populated suburb of Anchorage, suffered great damage. The frozen ground broke up into large 7 ft thick blocks.

The devastating slides in Anchorage had their locus of motion in the clay. The nearly horizontal movement in the biggest slide, in Turnagain Heights (Fig. 2-8), affected the stratum to a considerable depth, possibly below sea level. The slide moved essentially north and traveled a long distance (up to 1800 ft) into the sea. The top 7 to 9 ft of the otherwise unconsolidated deposit was frozen, and the ground broke up into large blocks, or "ratts" as the people called them. For this reason many residential structures survived the landslide movement. They tilted badly, and became completely unusable, but they did not collapse and crush their occupants.

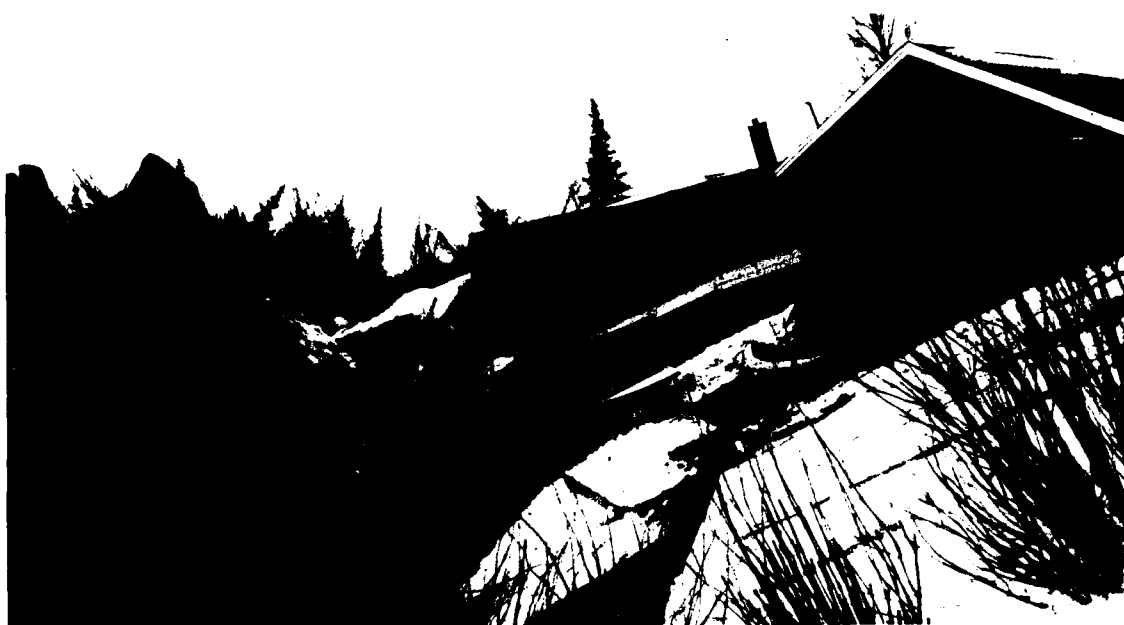
Figure 3. Blocks of frozen ground, or "ratts," as they were called by the local people, temporarily preserved many structures. A maximum of 1200 ft of shore bluff retreat was measured in the Turnagain area.

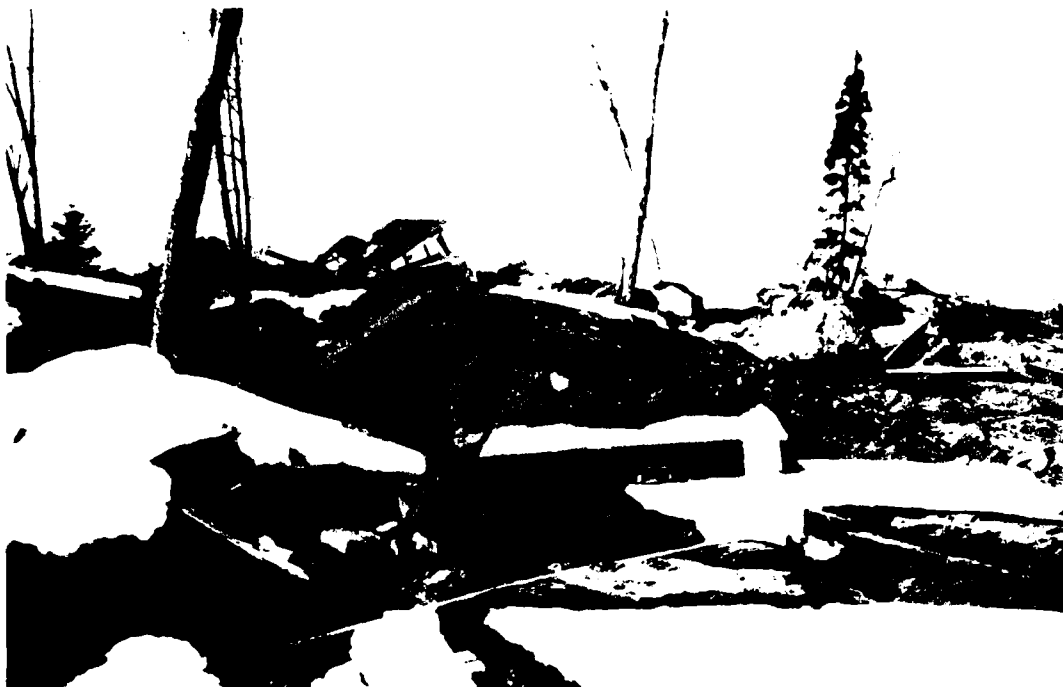
Figure 5. Paved surfaces. The several' fragments of pavement tailed in tens on between large blocks. In the lower left are portions of a cinder block garage. Cinder block structures were most sensitive to earthquake shocks. Where the ground was dry, it collapsed.

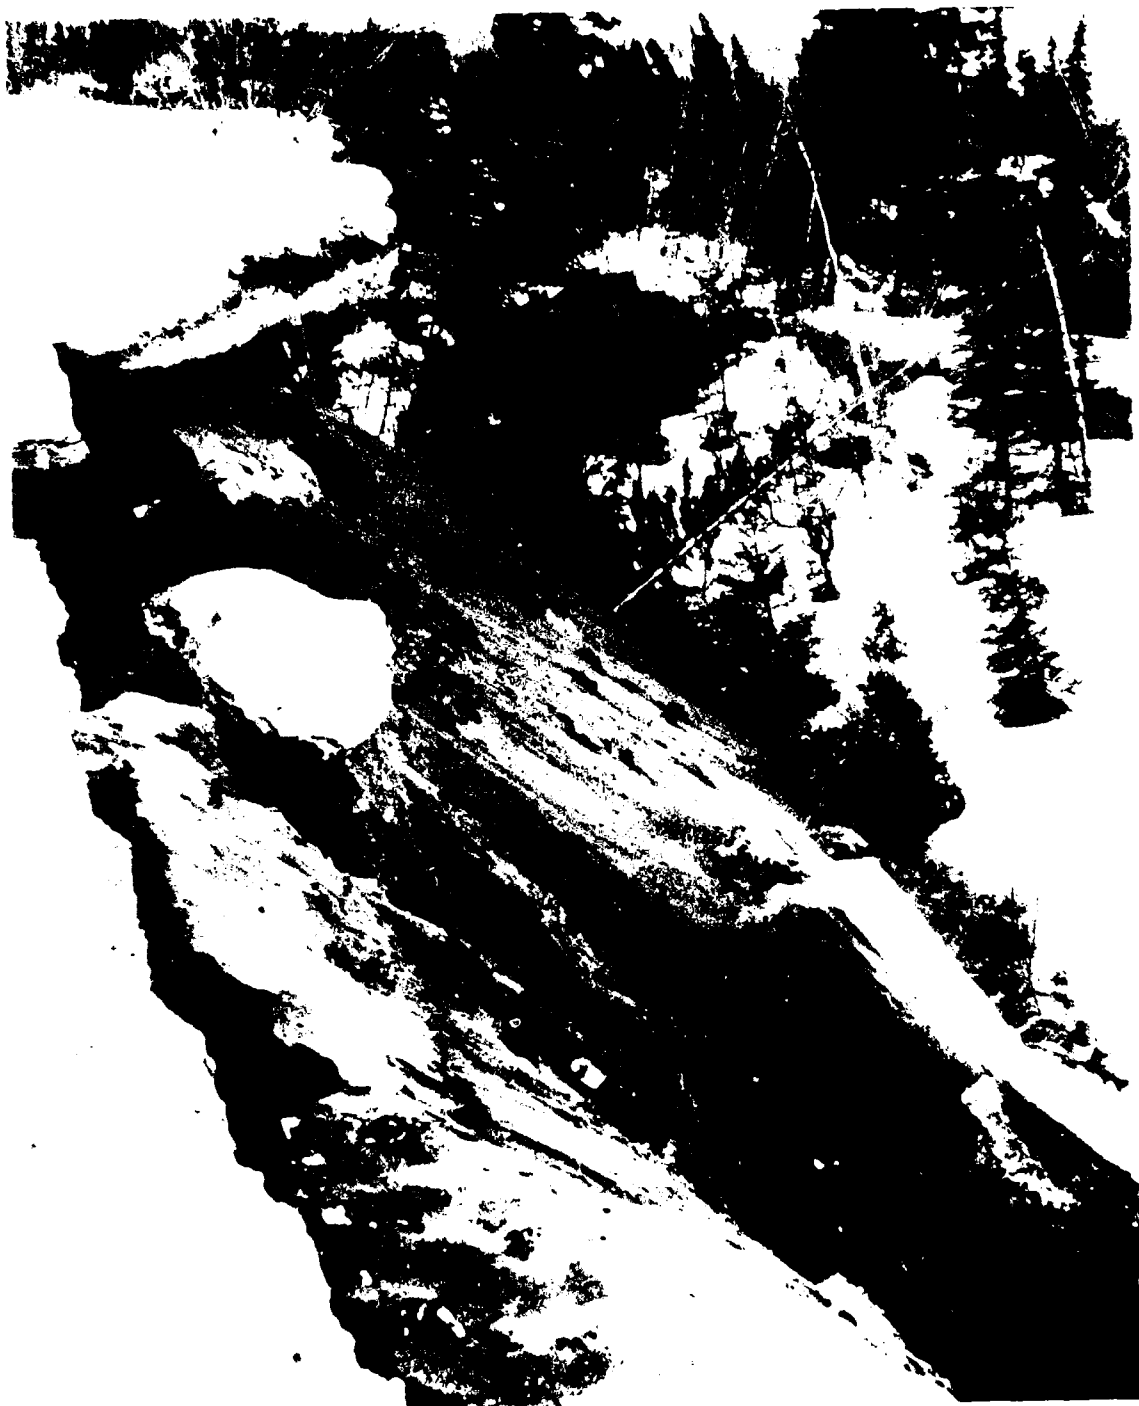
Figure 1. The scale escarpment. The following summer this slope retreated to the south. All Redwings above the escarpment were temporarily preserved.

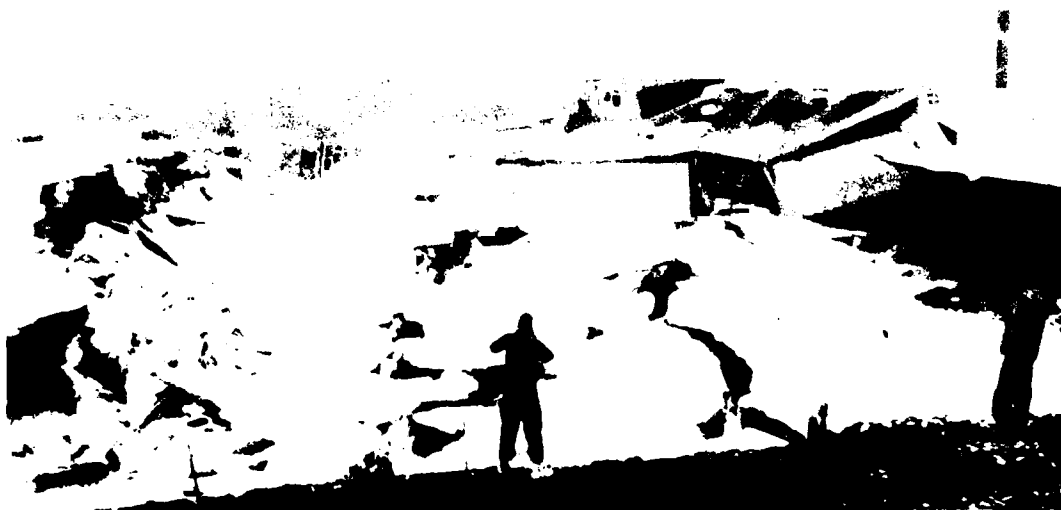
Figure 10 A destroyed school building in the Government Hill area in Anchorage. The vertical separation was 12 ft. The right fault ran through the middle of the building. The school was empty at the time of the quake and there were no victims.

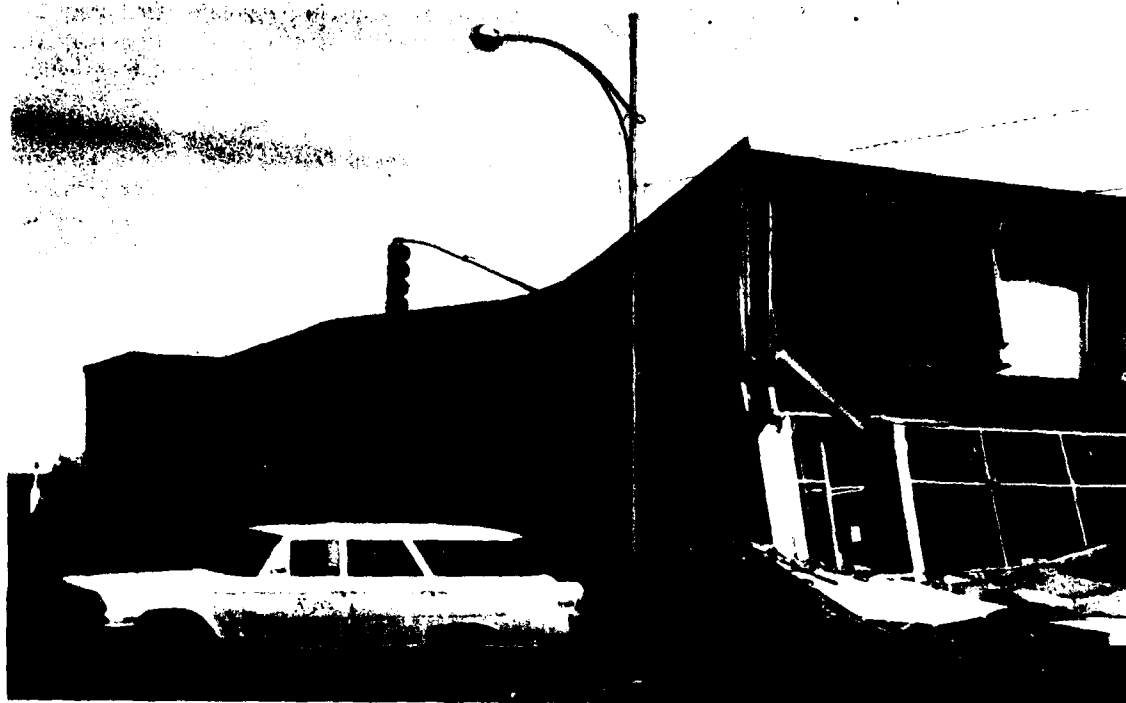
Figure 13. This structure in Anchorage was located over a subsidence and was violently damaged. Modern light construction prevented its total collapse. Old-fashioned masonry houses found in other earthquake regions such as around the Mediterranean Sea inevitably collapse into piles of rubble, resulting in large loss of property and life.

The overall view of damage to man-made structures (Fig. 13-17) leads to the impression that besides the soundness of the construction, the soundness of the subsoil—the ground on which they were built—determined whether or not they survived the Good Friday Earthquake. Log houses surrounded by frozen ground reaching bedrock ended up with nothing but cracked chimneys. Incompetent, sensitive clay resulted

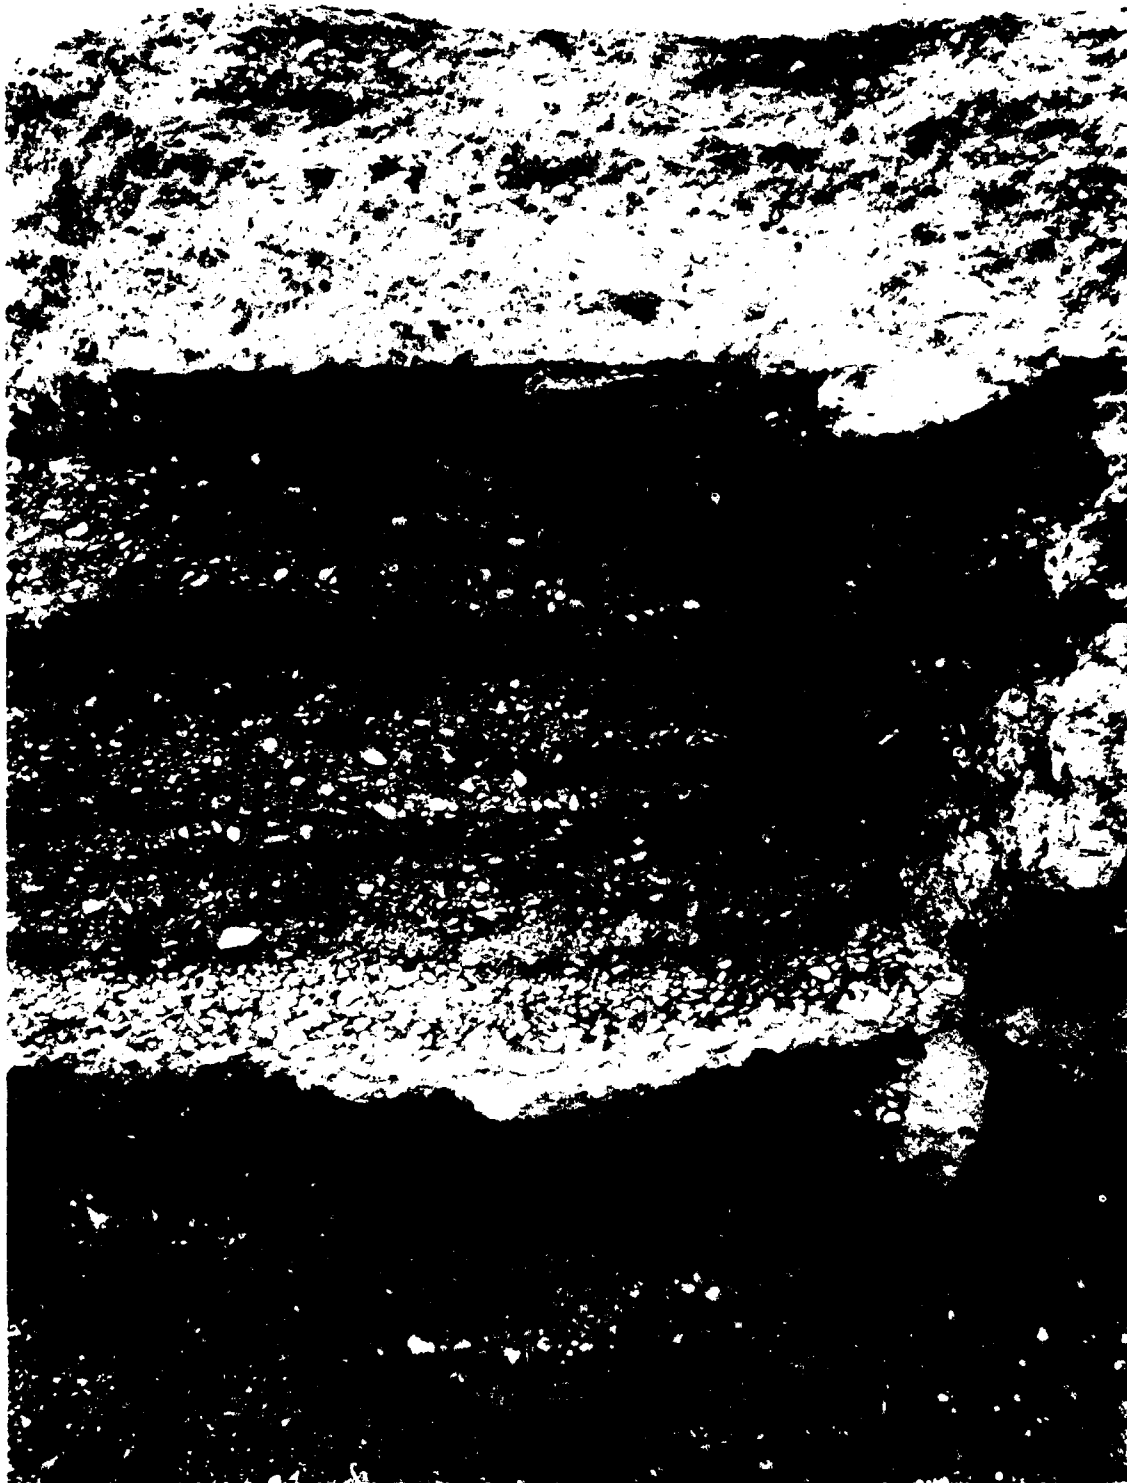
Figure 11. Frozen gravel exposed in Anchorage. The very top is constituted of completely ice-saturated material while the gravel at the bottom does not contain as much ice. Some of the top material is covered.

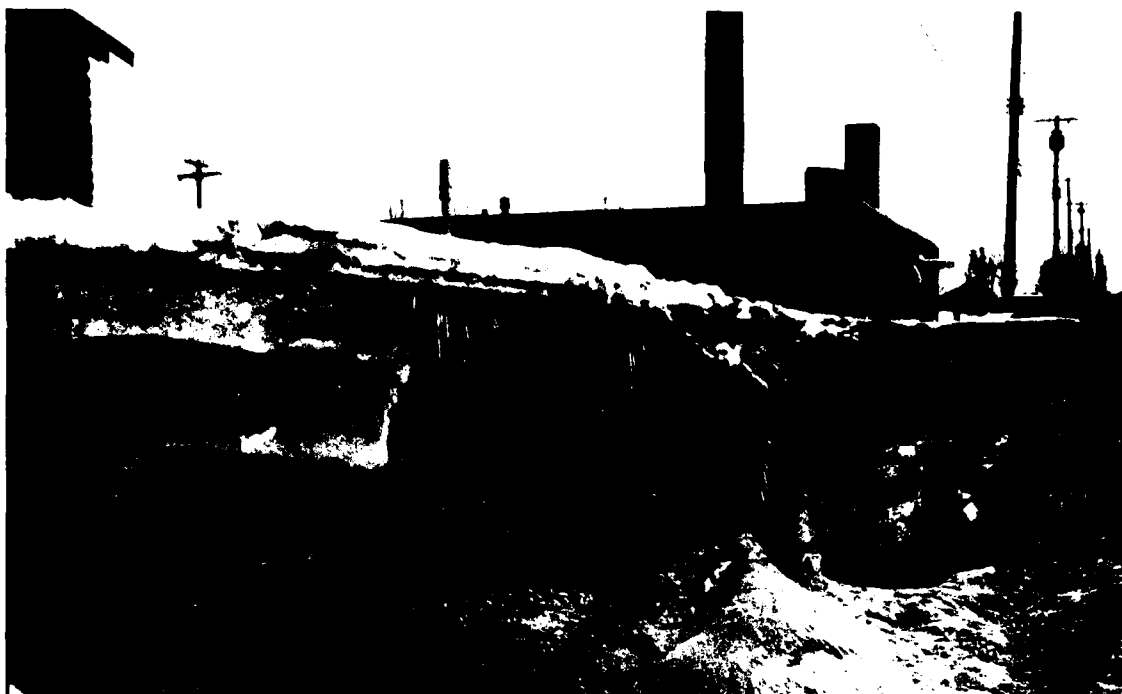
Figure 15. Fault scarp in Anchorage. The ice-saturated ground was frozen 7 ft deep at this location, temporarily preserving the two buildings and the utility line.

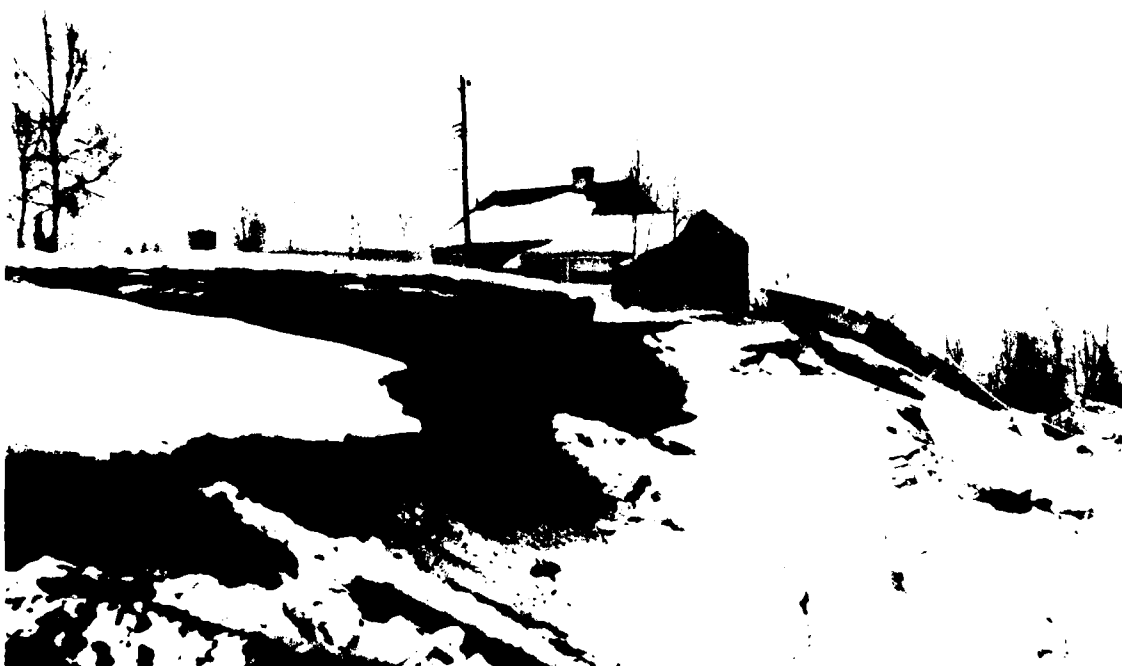
Figure 16. Government Hill in Anchorage. The 12 ft displacement appears to have caused only minimal damage to the building. Frost penetration was irregular but still sufficient to temporarily preserve the house.

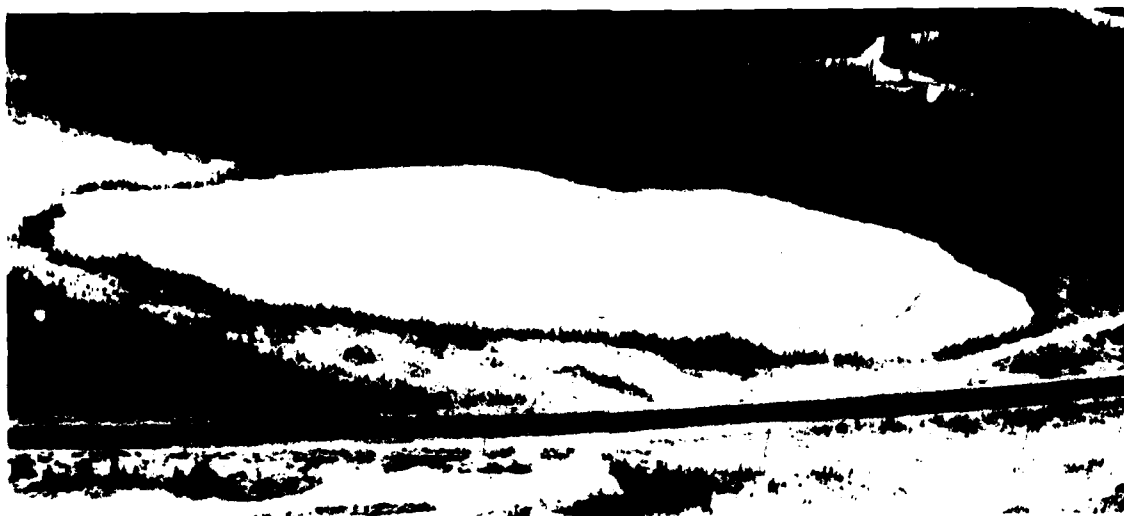
Figure 20. A lake on the Kenai Flats. On many small lakes the ice responded in a manner suggesting a seiche, or standing wave, response to the earthquake shock. Lakes with irregular shorelines broke up without showing any regular pattern.

completely. The circular pattern of disturbance could be easily imitated in a qualitative way in the laboratory. A round, shallow container with the bottom covered with water and a thin layer of fine-grained ice broke up upon disturbance in a circular pattern similar to that seen in Figure 20.

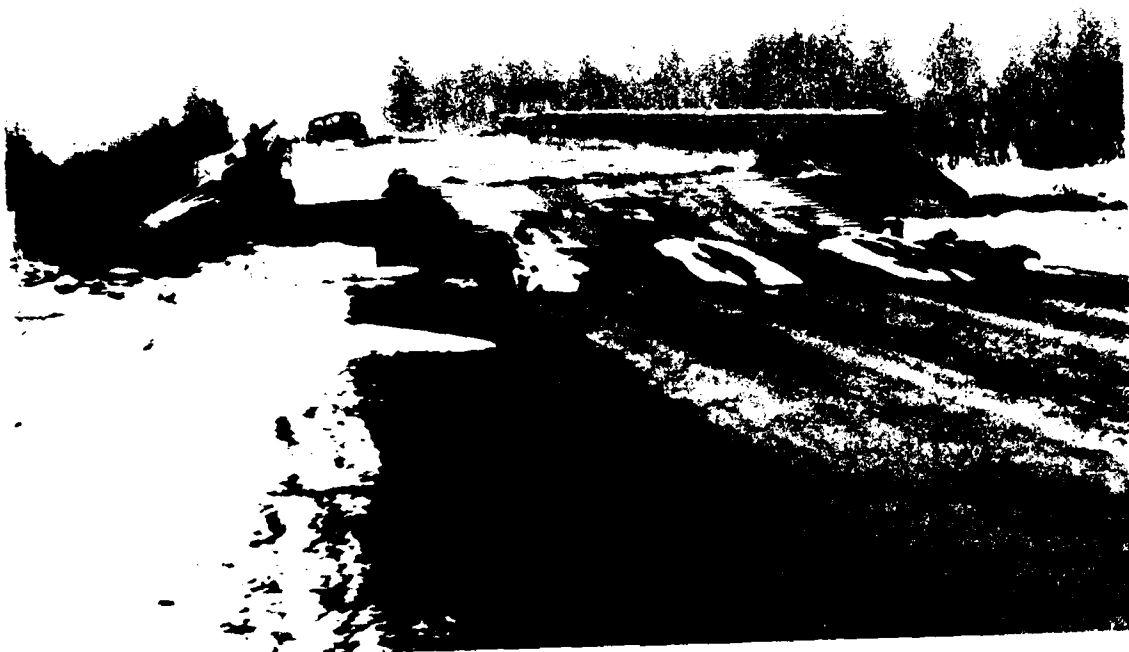
Figure 22 A pile foundation bridge in the Portage area. The ice encasing the pile clusters adhered firmly. The rapid rise and fall of the water in the stream resulted in a regular uplift. Some till and lumber were used to make it passable.

around embedded piles of shore installations may be significantly different from the cases illustrated in Figures 22 and 23. Figure 22 shows a rigid reinforced concrete structure resting on eight piles embedded into unfrozen, unconsolidated water saturated river deposits. The total weight of the 24 x 60 ft reinforced concrete structure was probably in the vicinity of 200,000 lb. The bond strength between the piles and the surrounding ice was 100 to 150 psi (instantaneous resistance; long term application would produce less). The skin friction of the bearing parts of the piles embedded in the river bottom was between 1 and 5 psi.

The eight 14 in. diameter piles had a total of about 422,000 in.² of skin contact with the unconsolidated riverbed deposits. This made a pull out resistance of approximately $(422,000 \times 2) = 844,000$ lb. Adding to this the weight of the bridge gives over 500 tons of pull out resistance. The ice to which the force of the passing wave was applied had a total surface area in contact with the piles of about 12,600 in.². At 150 psi of bond strength between the ice and the piles, a lifting force of approximately 950 tons could have been applied to the bridge. Therefore, the bridge damage mechanism suggested in Figure 21 is plausible.

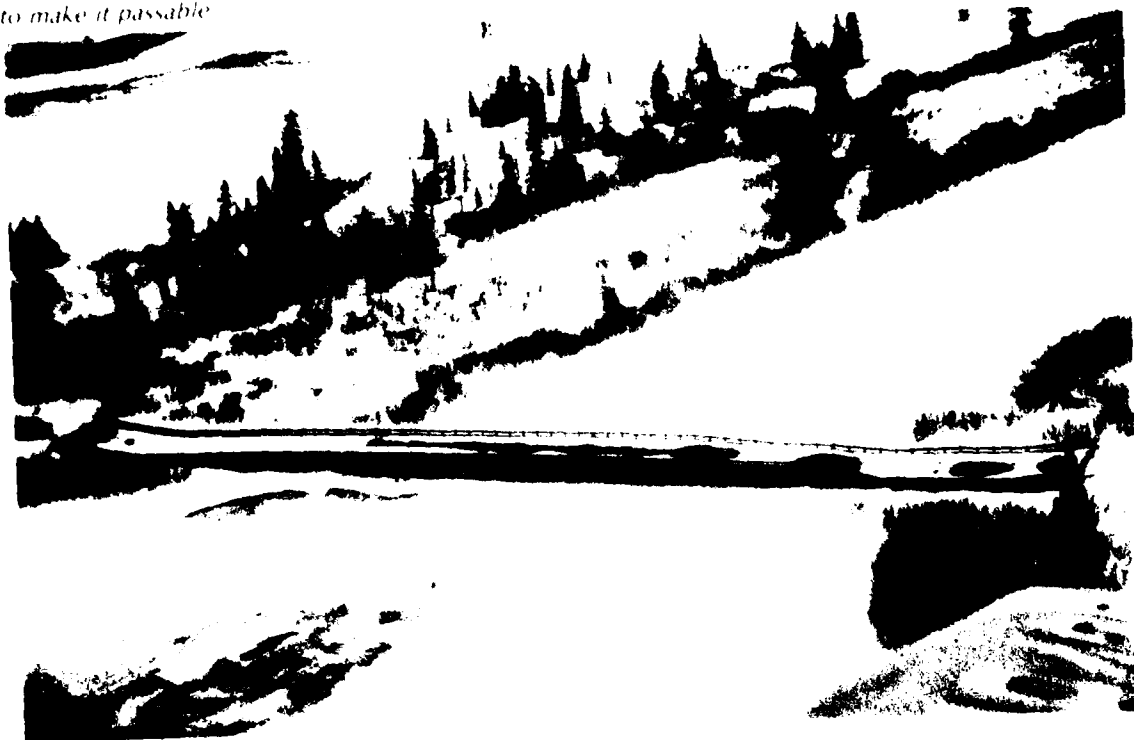
Figure 23 Differential heave. Parts of this bridge were differentially uplifted by the mechanism indicated in Figure 21. Due to the different composition of the materials in which the pile clusters were embedded, the bridge settled differentially.

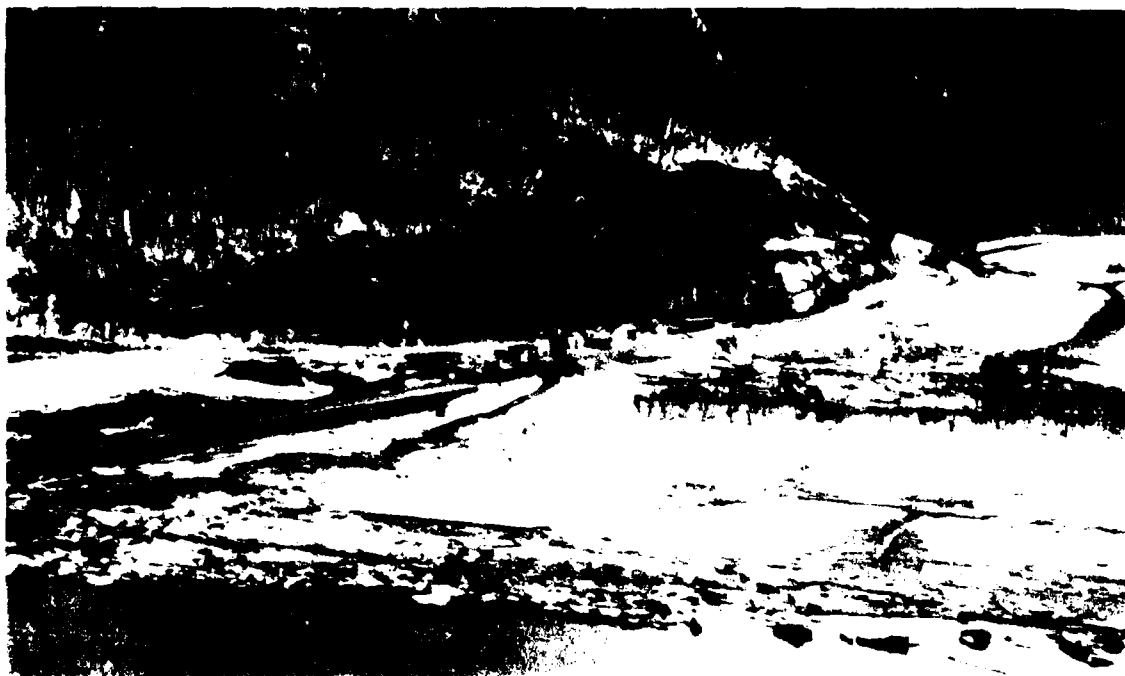
Figure 24. Aftermath of Flash Flood on the Knik River. The flood was released when most of Lake George was emptied by the earthquake. The highway was obstructed by a slide and the floodplain, frozen several feet deep, was cracked by the earthquake and flooded when the water from Lake George passed through.

Lake George, also drained abruptly due to the earthquake (see Fig. 24). The Copper River Valley contains a very large amount of massive ground ice, and streams "disappear," as local people say, underground. The earthquake resulted in the collapse of numerous thermokarst cavities and fresh exposures of unusually massive ground ice. As Figures 25-31 show, the effect of the earthquake on the mountains, snowfields and glaciers was dramatic and significant.

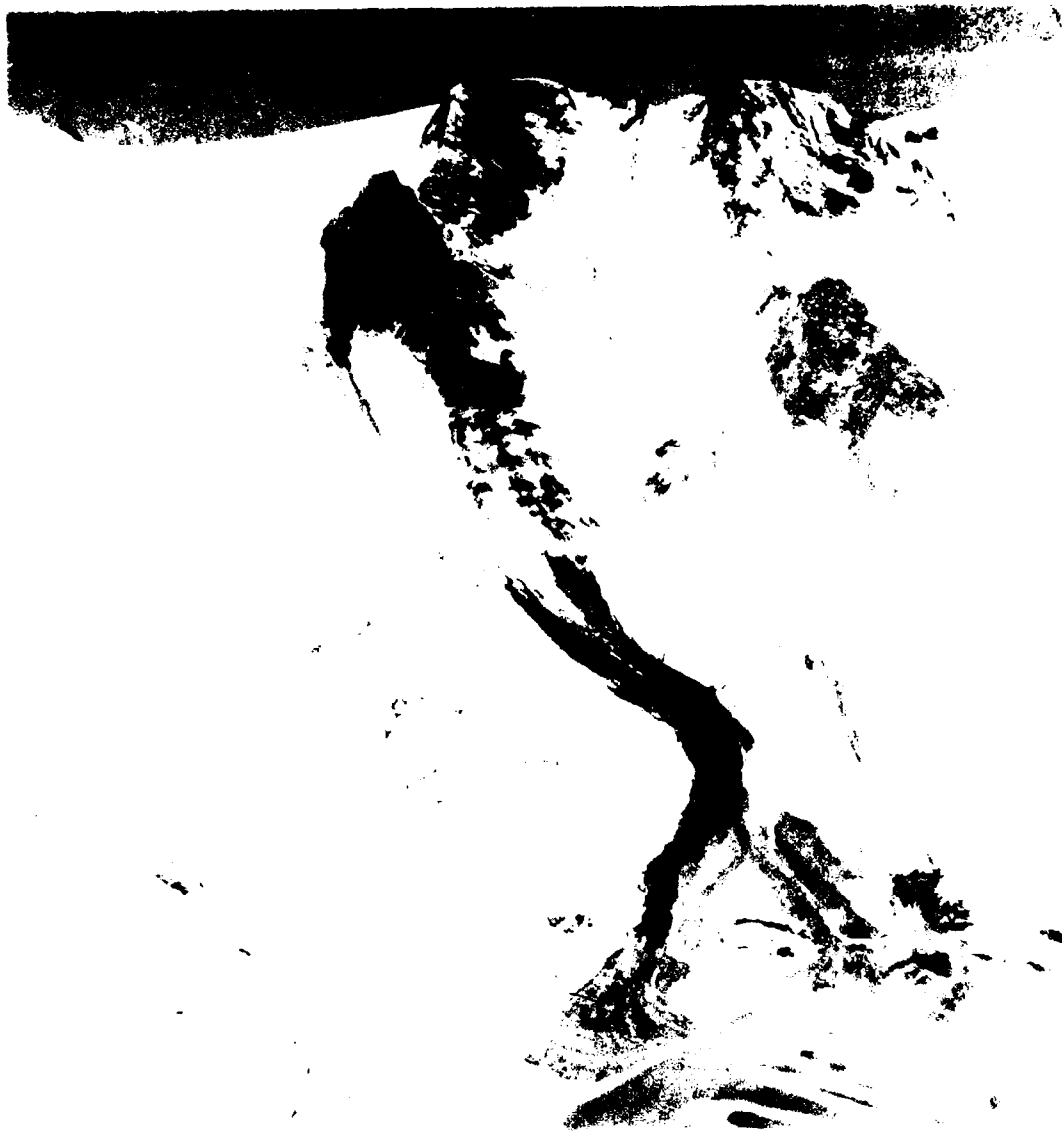
Figure 25. Rock avalanche. A large rock flow on the Yalik Glacier came to rest at the bottom in a way suggesting fluid flow.

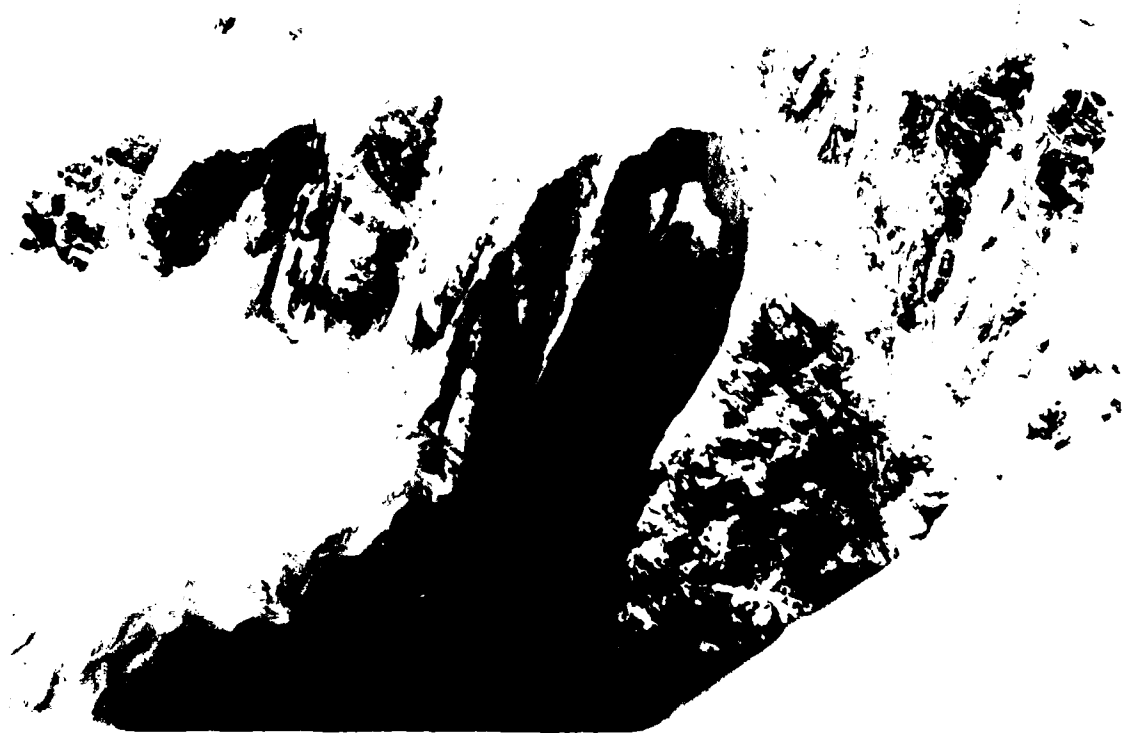
Figure 27. Dingelstad Glacier. The large rock slide landed in the fiord, apparently shattering a part of the glacier snout. A strong subglacial stream emerges at the lower left.

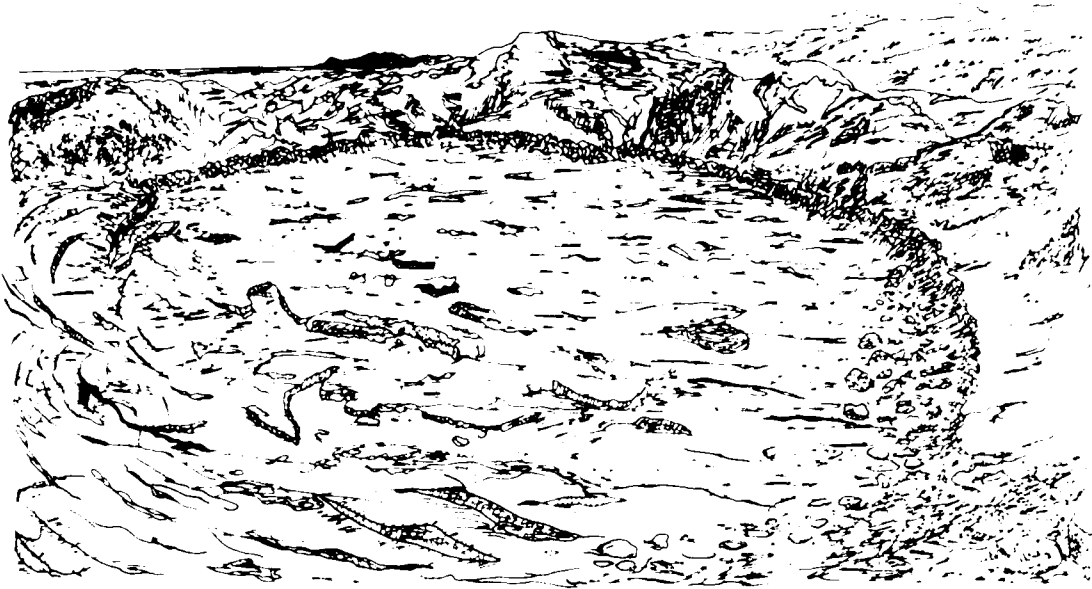
Figure 28. The western embayment of the Columbia Glacier. The drawing, representing a 1000 ft. by 1000 ft. area, is a composite made from oblique aerial photographs caused by the earthquake.

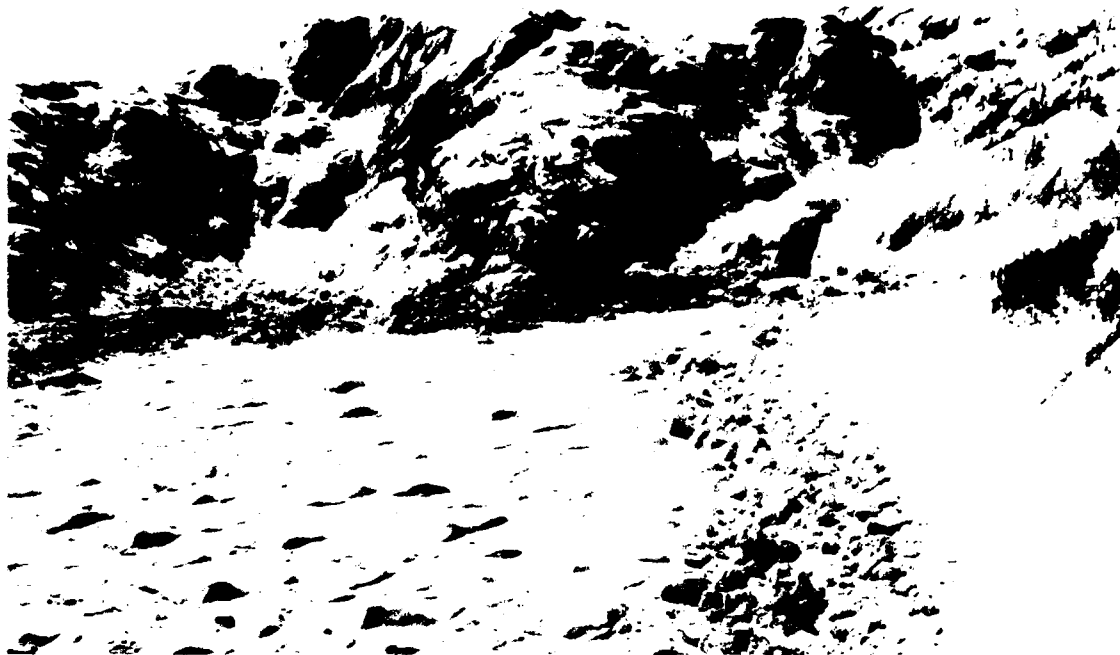
Figure 30. Columbia Glacier. The crushed glacial erratics escaped from the glacier during the earthquake. The area of the embayment dropped significantly. This area was very close to the earthquake's epicenter.

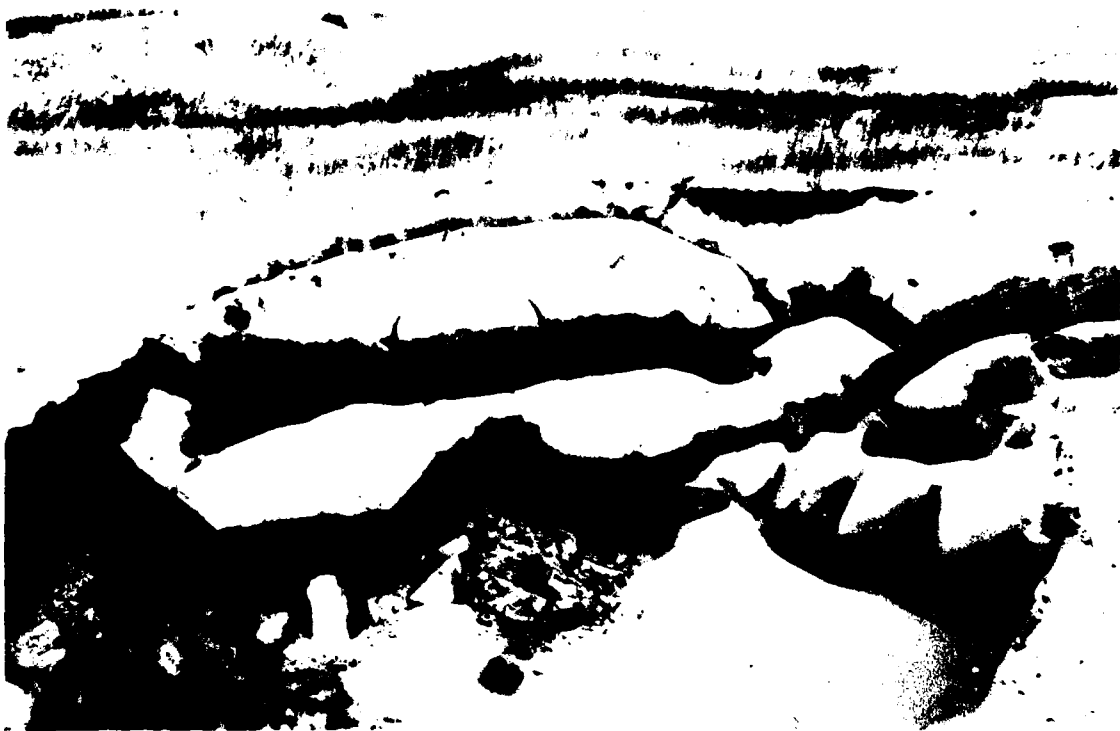
Figure 31. Massive ground ice exposure in the Copper River Valley. The ice had 7 ft of overburden. This photograph shows a thermokarst area. The ice collapsed during the earthquake. The vegetation consists of willows 7 to 15 ft high.
